# CITY OF BUFFALO MUNICIPAL FACILITY NEEDS ASSESSMENT

BKV Project No. 2519-01  
Date: September, 2023

The City of Buffalo engaged the BKV Group team to provide a Municipal Facility Study and Master Plan of 12 city facilities, to inform long-range capital improvement and fiscal planning. The study is inclusive of two key components: assessment of current site and facility conditions for each building (material, infrastructure, systems, and code compliance), and evaluation of each department's operations and staffing relative to available space and capacity. These two efforts provide the City with an objective and holistic understanding of both necessary and recommended long-range investments, ensuring the longevity of these facilities as city resources, and in service of high-quality, consistent operations and services for the residents of Buffalo. Project outcomes include itemized facility assessments, prioritized by criticality; a quantitative space program for each department, including projections at future milestones; graphic diagrams representing adjustments to the existing facilities and/or sites to meet the projected space needs and fulfill the project's guiding principles

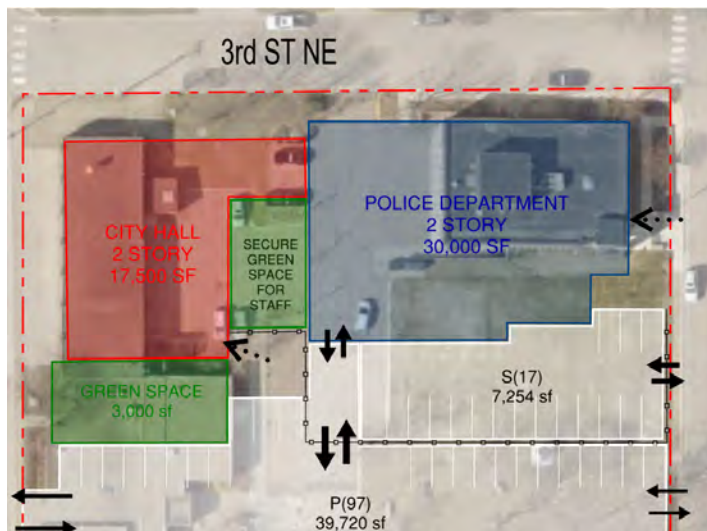
POLICE DEPT SITE PLAN: Option 2 (in blue)

- Options 2 and 3 expand the facility west to create a physical connection to a future new City Hall, with a secure green space for staff separating the two.

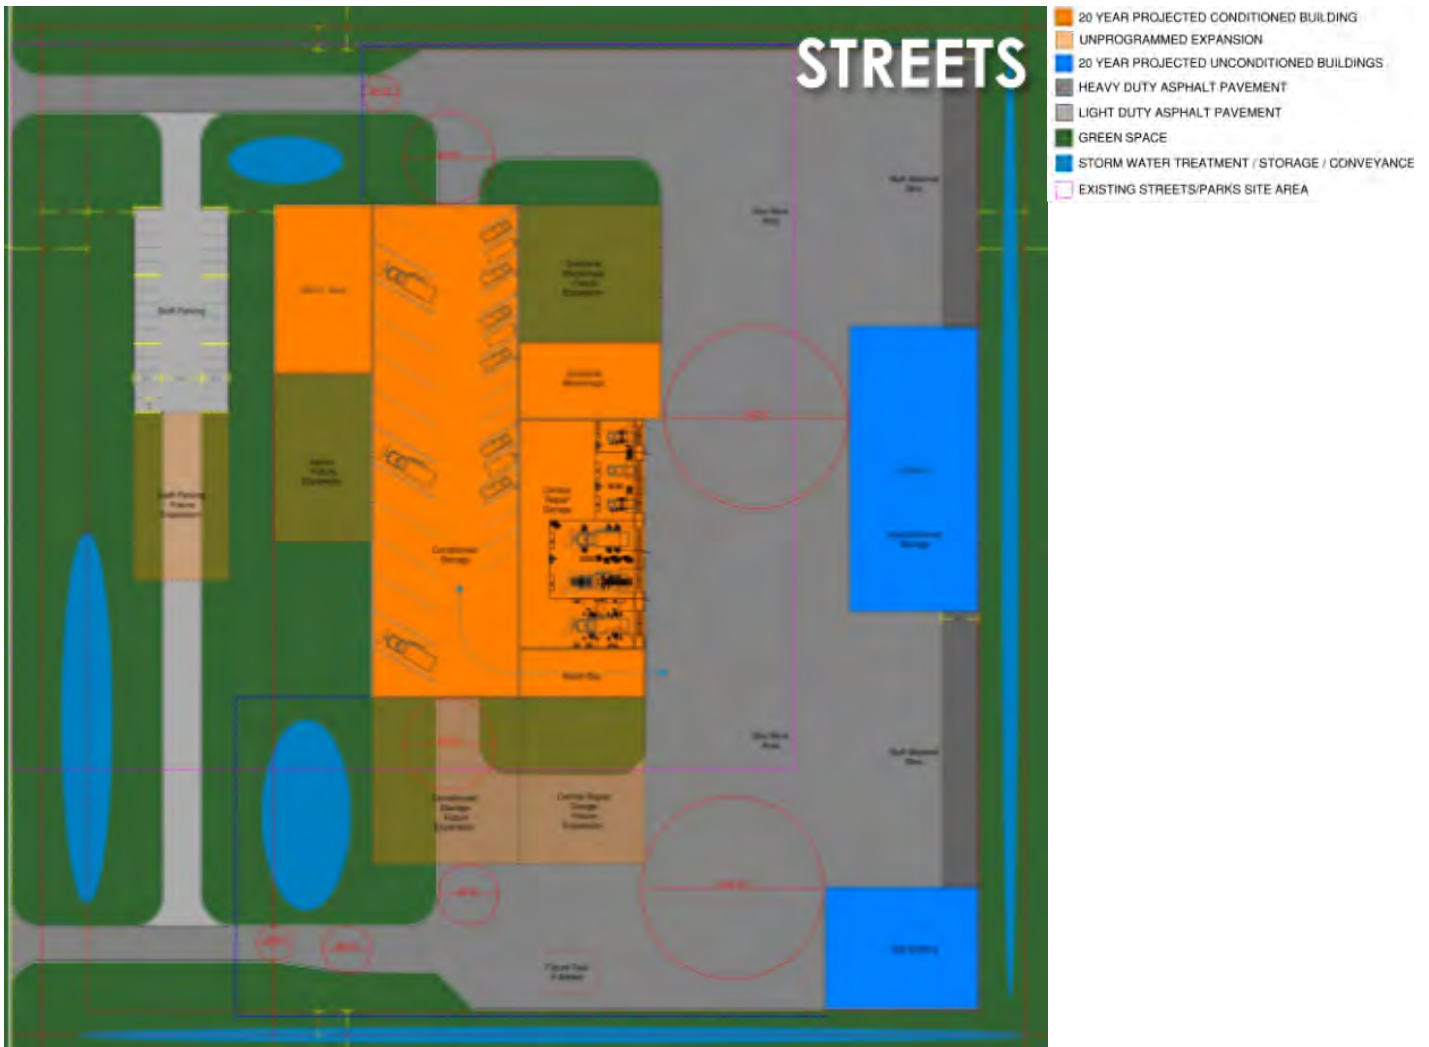
STREETS SITE PLAN: Conceptually Proposed Site Plan

- Provide ample conditioned storage with adjacent washbays and repair garages, divisional workshops, and administration/personnel areas; while also planning for future expansion areas.
- Ample area for site work, unconditioned storage, and bulk material storage
- Planned areas designated for fueling, either now or in the future

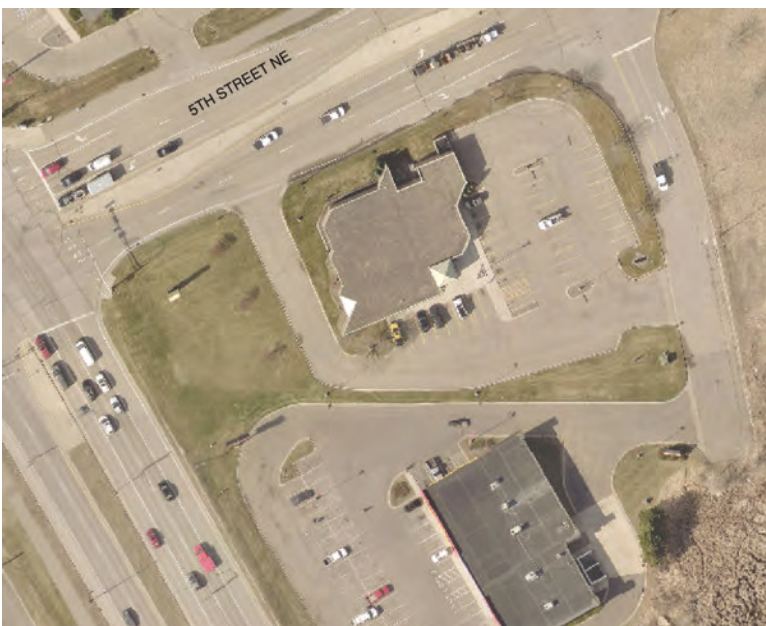
**BUFFALO WINE & SPIRITS, HIGHWAY 55**  
The existing site has significant setbacks from Highway 55, and a building layout whose geometry complicates expanding either the retail or the support areas without significantly compromising site access and parking.

Retail and storage floors are beyond capacity, limiting access for patrons and staff.

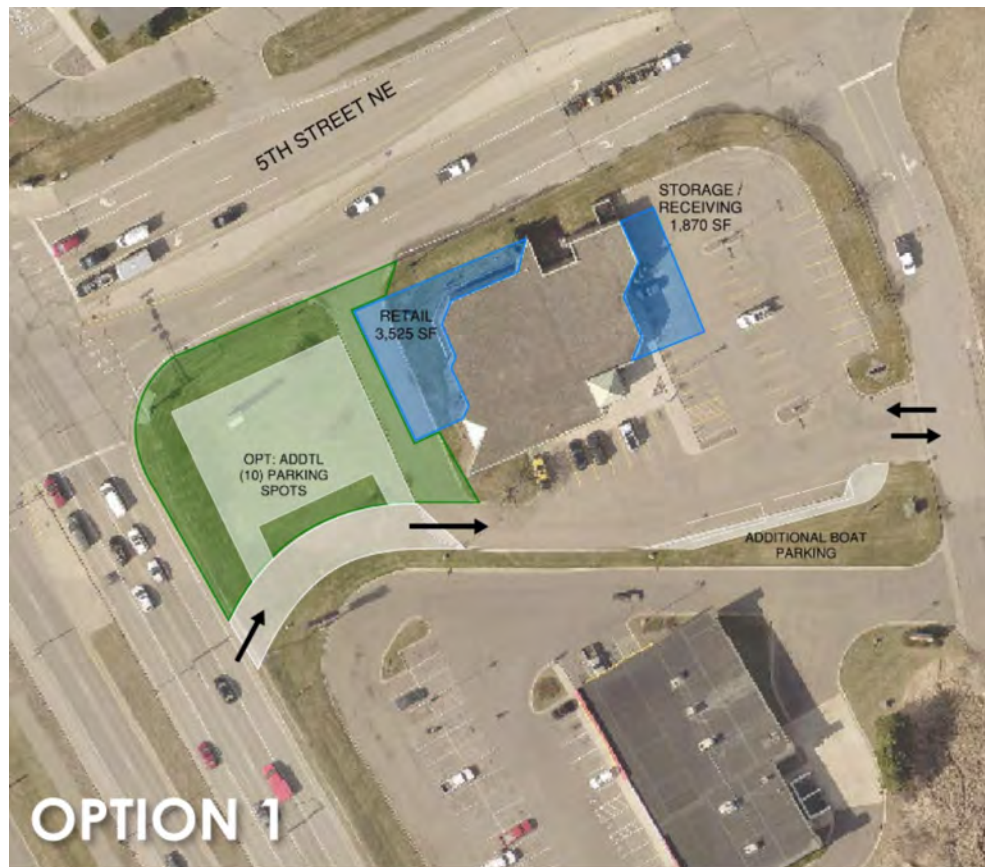
BUFFALO WINE & SPIRITS SITE PLAN (OPTION 1):  
Existing Site and Facility, With Expansion. Access from Highway 55 subject to MnDOT.

- Increased retail floor area
- Increased storage and receiving
- Potential new turn-off and parking from Hwy 55, subject to MnDOT approval (challenging and potentially requiring a long approval timeline)
- Additional parking: dedicated boat/trailer parking, and optional additional passenger parking
- NOTE: a new construction building could be design as a one-story facility, could be planned for future vertical expansion (capacity in foundations and structure), or could be built as a two-story building with the second floor awaiting fit-out at a later date, to provide long-term capacity.

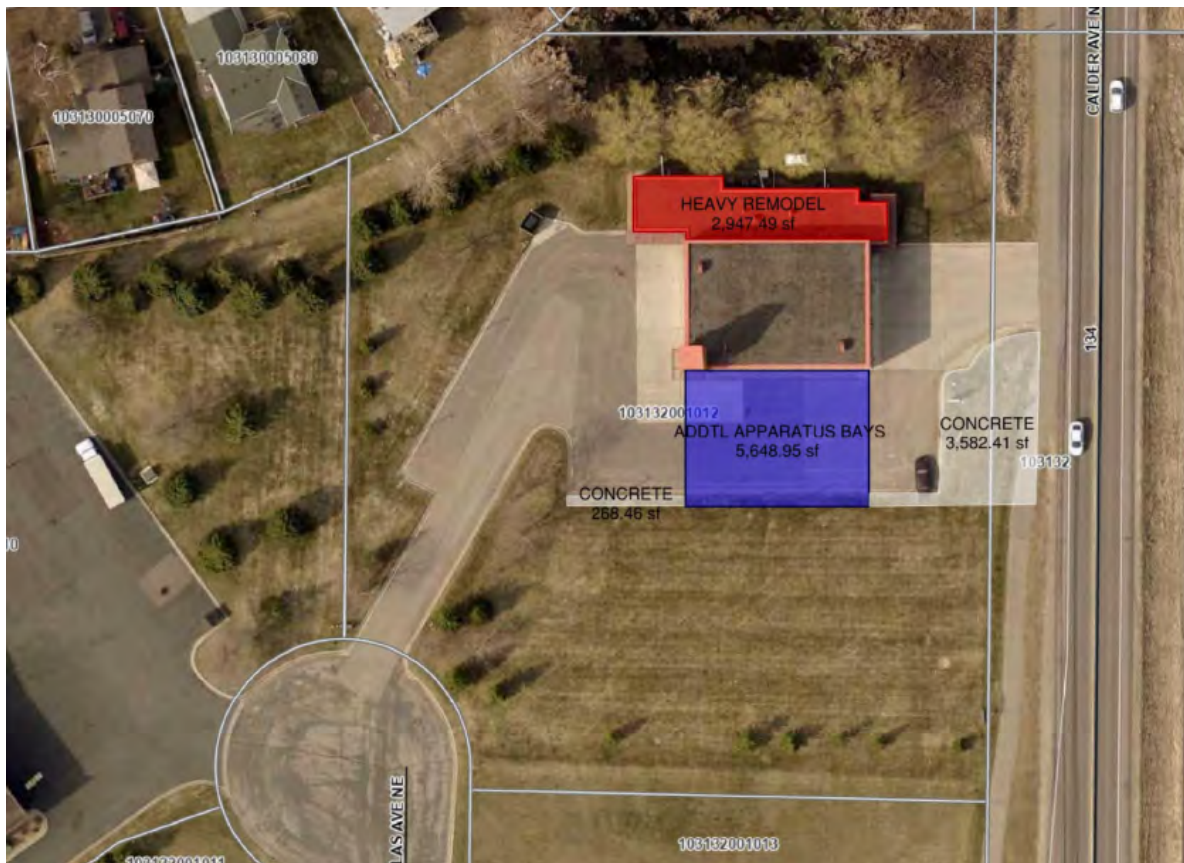
- Planned renovations (2022+) will begin providing separation of turnout gear storage.
- Additional apparatus bays can be accommodated on this site which will address space needs and the current shortcomings that impact true pull-through use.
- New bays can be located to the south of the existing station, where there is currently a large concrete apron. Expansion of some of the site concrete will allow for true pull-through utilization of the new bays.

FIRE STATION SITE PLAN: Existing Site and Facility With Expansion

- I. Centennial Fire Station:** For long-term operations, this facility's operations would benefit from investment to provide current industry-standard cancer prevention measures, and an additional apparatus bay which would allow the city to provide industry-recommended redundancy of equipment for each station on either side of the railroad line. The existing site has capacity for this expansion, and interior renovations and the apparatus bay expansion could be completed in phases.

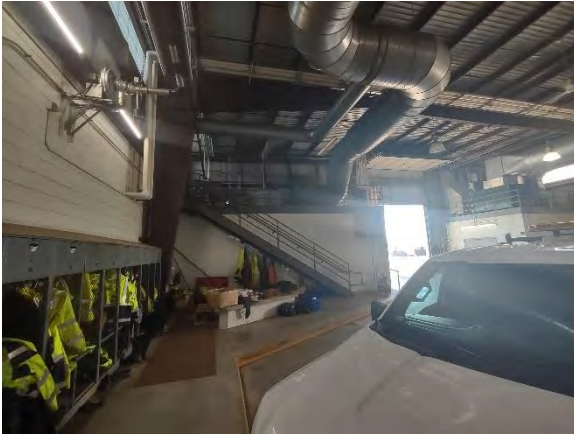
Primary personnel lockers within vehicle area [Not ideally recommended for primary lockers]

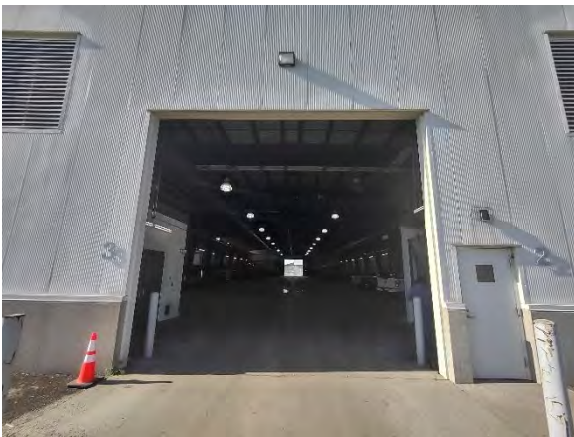
North facing access door – primary vehicle entry

Exterior apron includes snow melt system

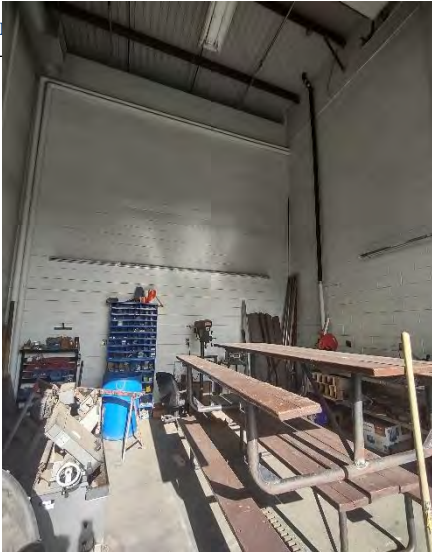
Welding and fabrication bay.

Good height, but insufficient floor area to be utilized as a high-lift work bay.

Minimal area to circulate around projects, projects must be brought outdoors for completion or location to another work space for completion of work.

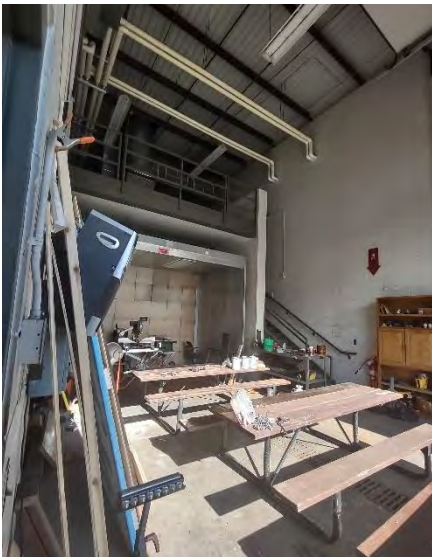
Wood shop / Paint Booth and Mezzanine

Mechanical mezzanine locates equipment off of valuable work floor space.

Paint booth is used on occasion for fume control, also houses wood working tools.

Floor area large enough to allow projects to be worked on and circulation around.

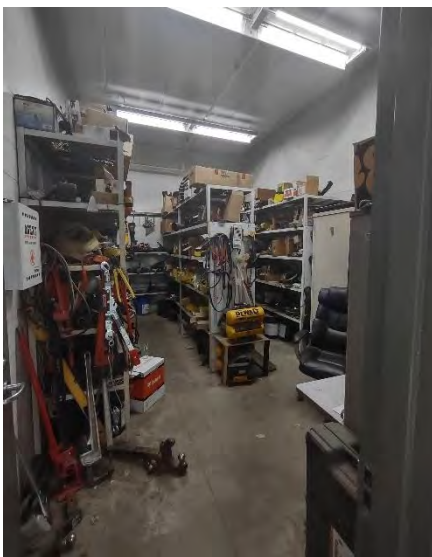
Parts and tool storage room and vehicle maintenance office.

At capacity, though well organized.

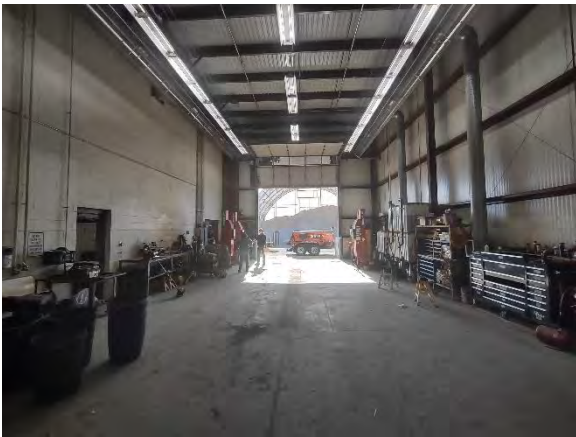
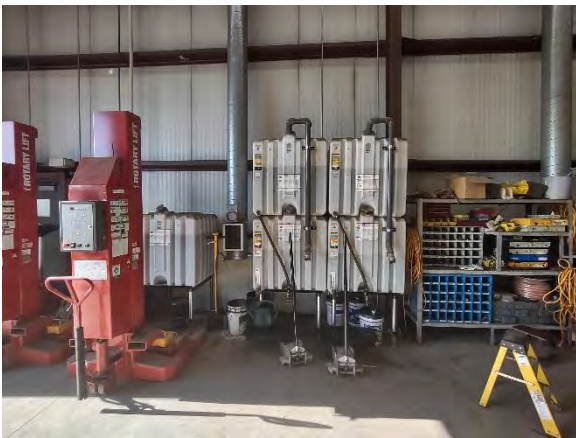
Vehicle Maintenance Bay (VM)

Floor is in good condition.

- Lack of length and width.
- One bay is substandard for maintaining fleet. Two to three bays to accommodate multiple vehicle types and broken down equipment allowing service on others is standard.
- Separation of specific material storage (bulk fluids, small parts, tools) is not of a size to meet best practices

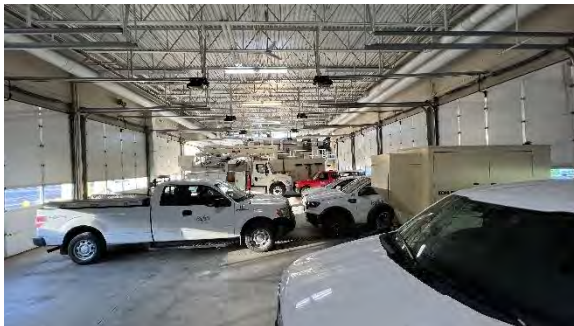
Wash and Emergency Bays

Floor is seeing some degradation of the surface due to wet/dry cycles with salt water intrusion. Trench drain frames are showing signs of failure, or are in a state of failure.

- Vehicle Storage Space
- Floor surface issues (aesthetic and cleanliness issues, structural performance should be OK)
- Trench drain failures

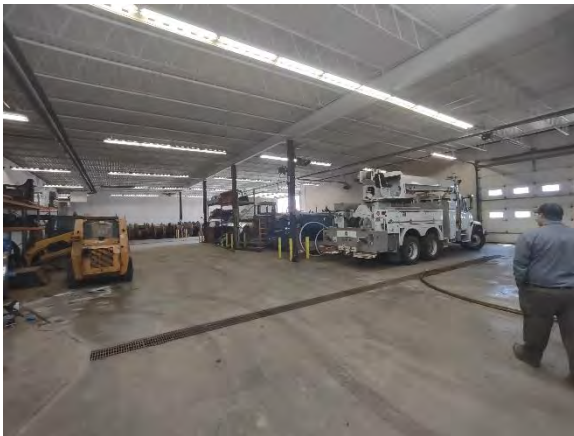
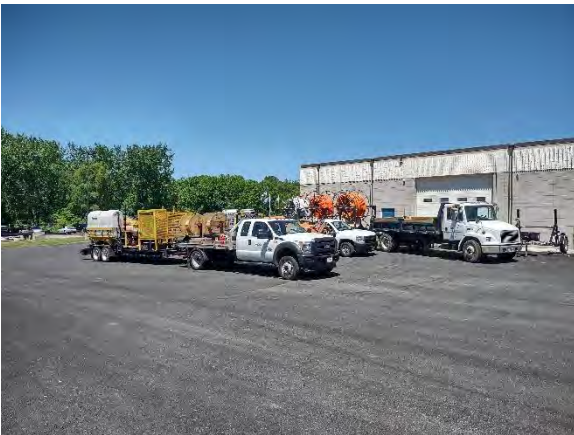
### Old Facility – 1982 & 1989 Buildings

- Layout for storage of operational equipment
- Older building envelope requiring higher maintenance and reduced energy efficiency.

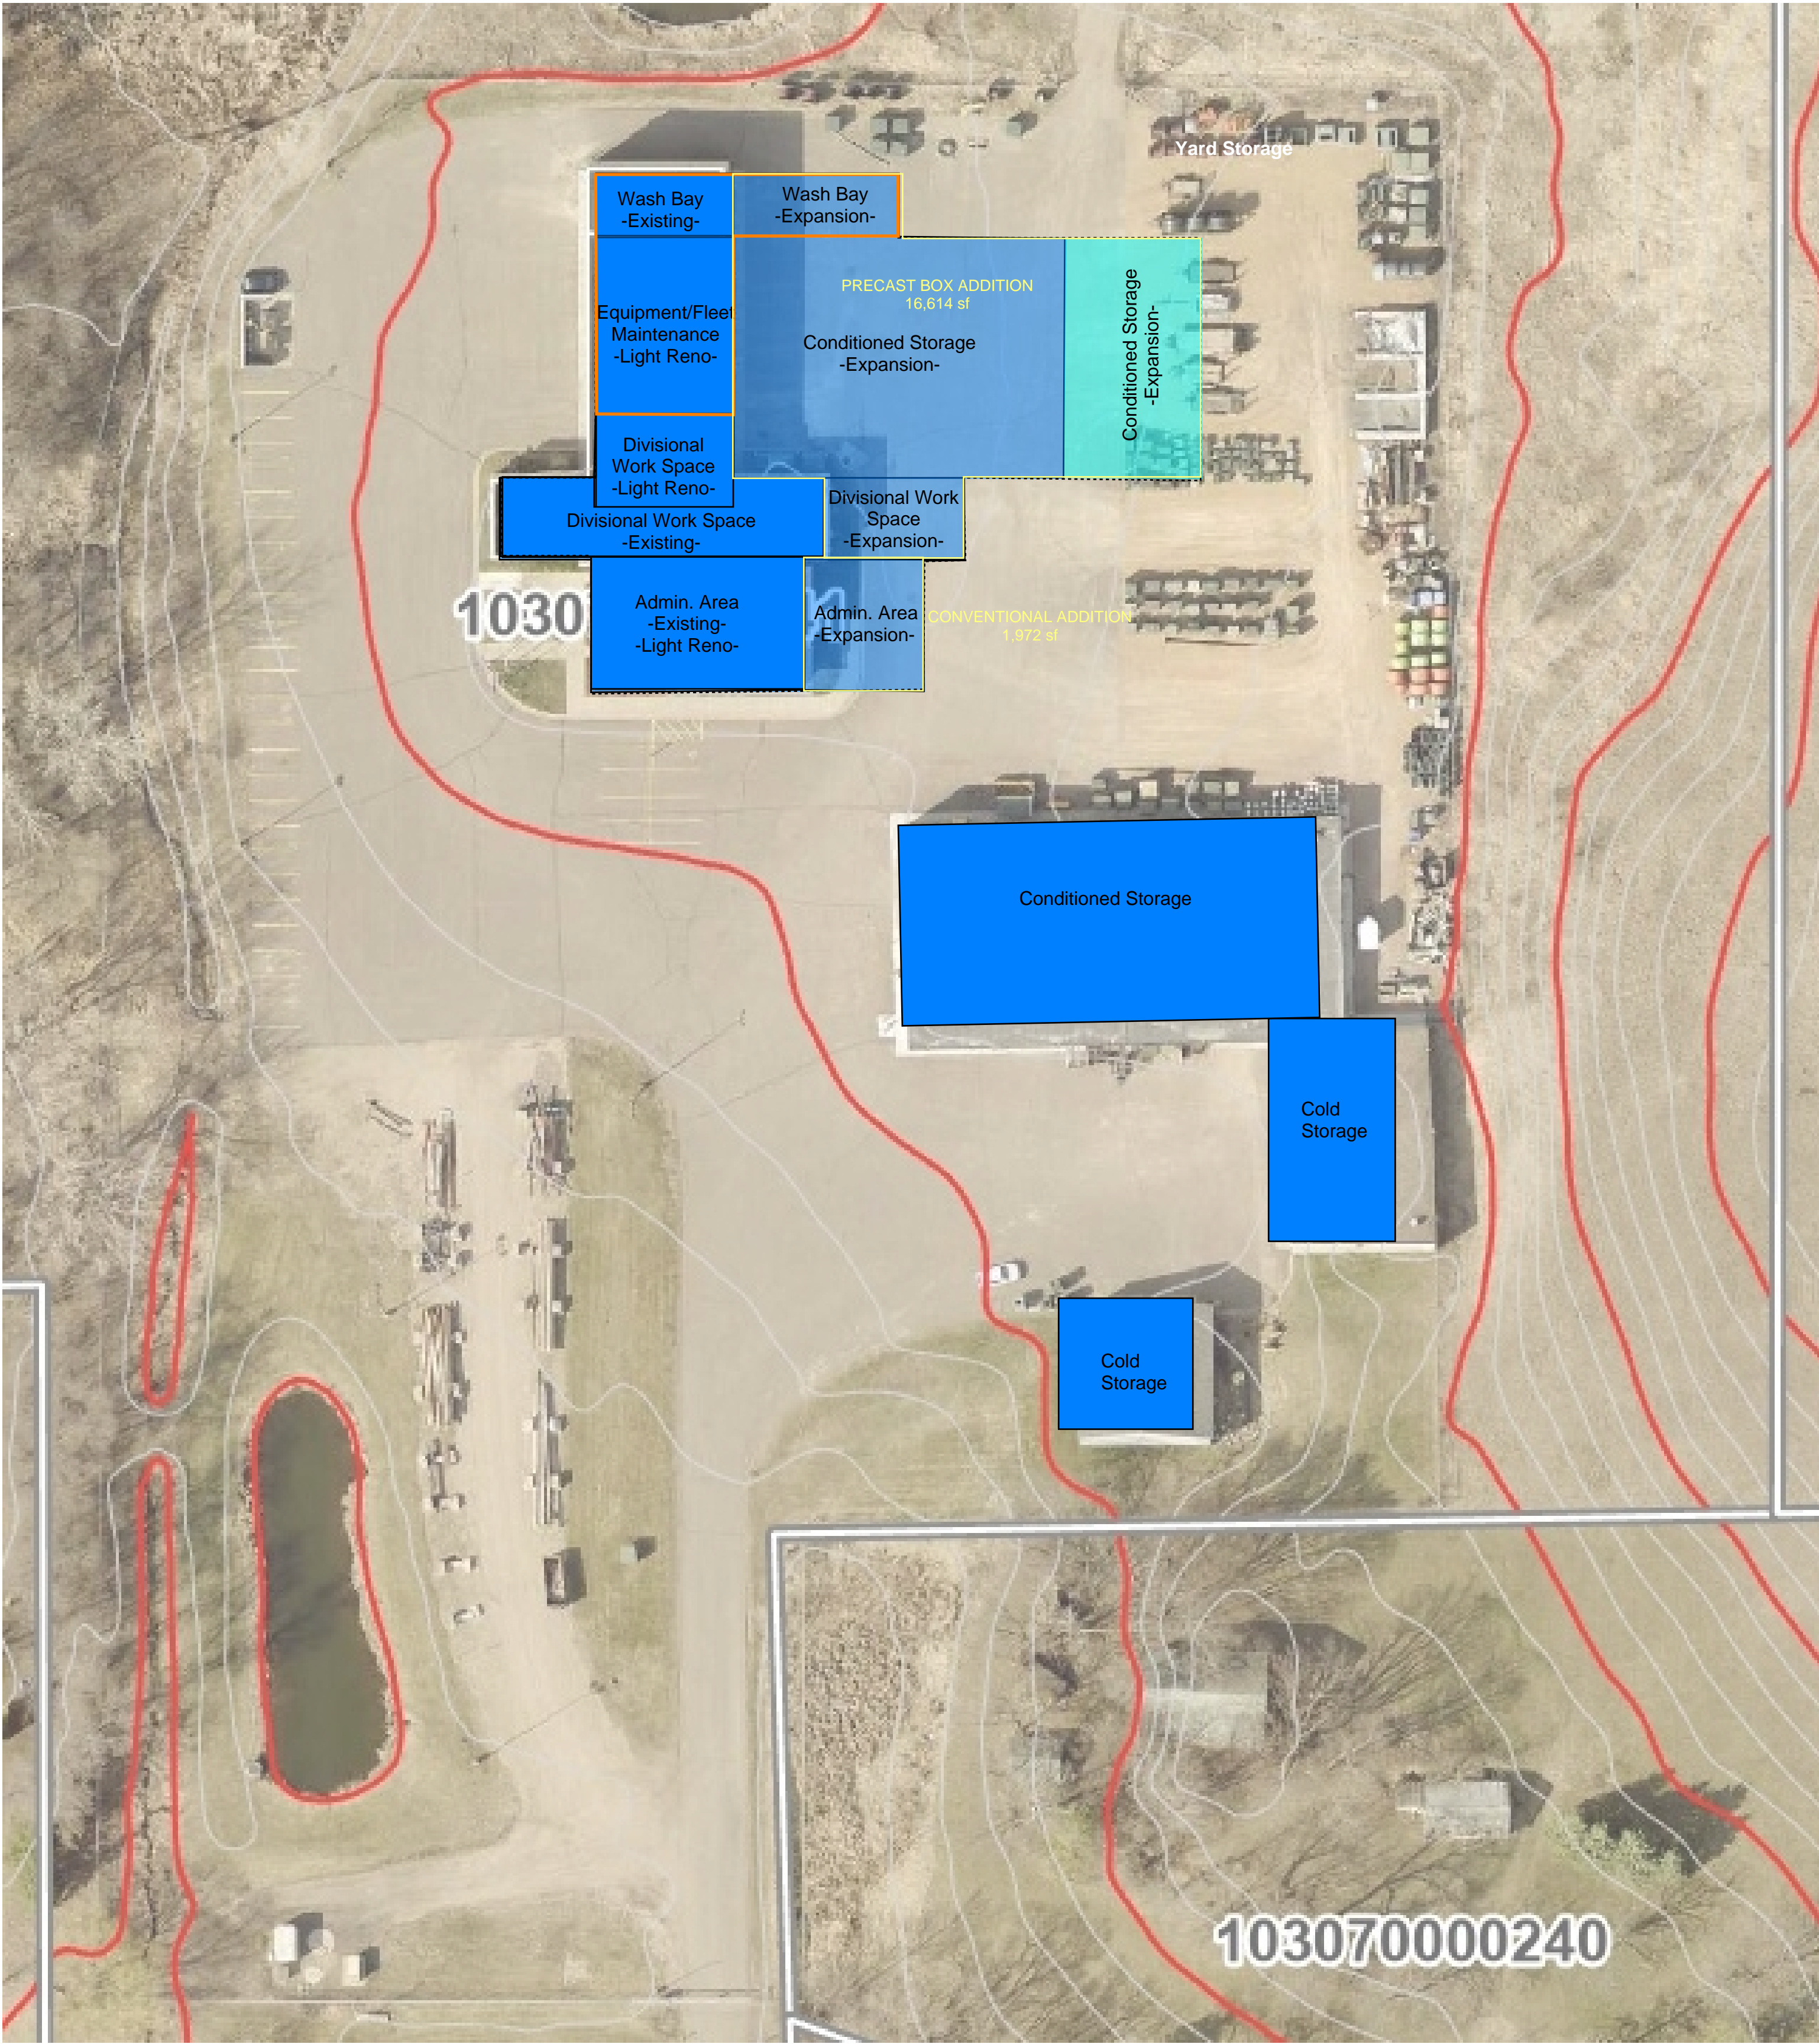
Functional Component	Existing SF	Streets and Parks			
		Existing Need	Area Required		
			5-YR Projection	10-YR Projection	20-YR Projection
Administrative Area	3,925	8,372	8,733	8,733	8,851
Conditioned Storage	18,810	39,006	44,384	44,384	47,461
Equipment / Fleet Maintenance	4,090	11,304	11,304	11,304	11,304
Divisional Work Space	4,227	5,531	5,749	5,749	5,865
Net SF Subtotal	31,052	64,213	70,171	70,171	73,521
Circulation and Structure Allowance		12,296	12,614	12,614	12,770
Programmed Gross SF	31,515	76,509	82,785	82,785	86,290
Unconditioned Storage	9,985	17,686	18,198	18,303	18,575
Site Work Area(s)

- EXISTING BUILDING
- CURRENT NEED AREA
- 20-YEAR PROJECTED NEED

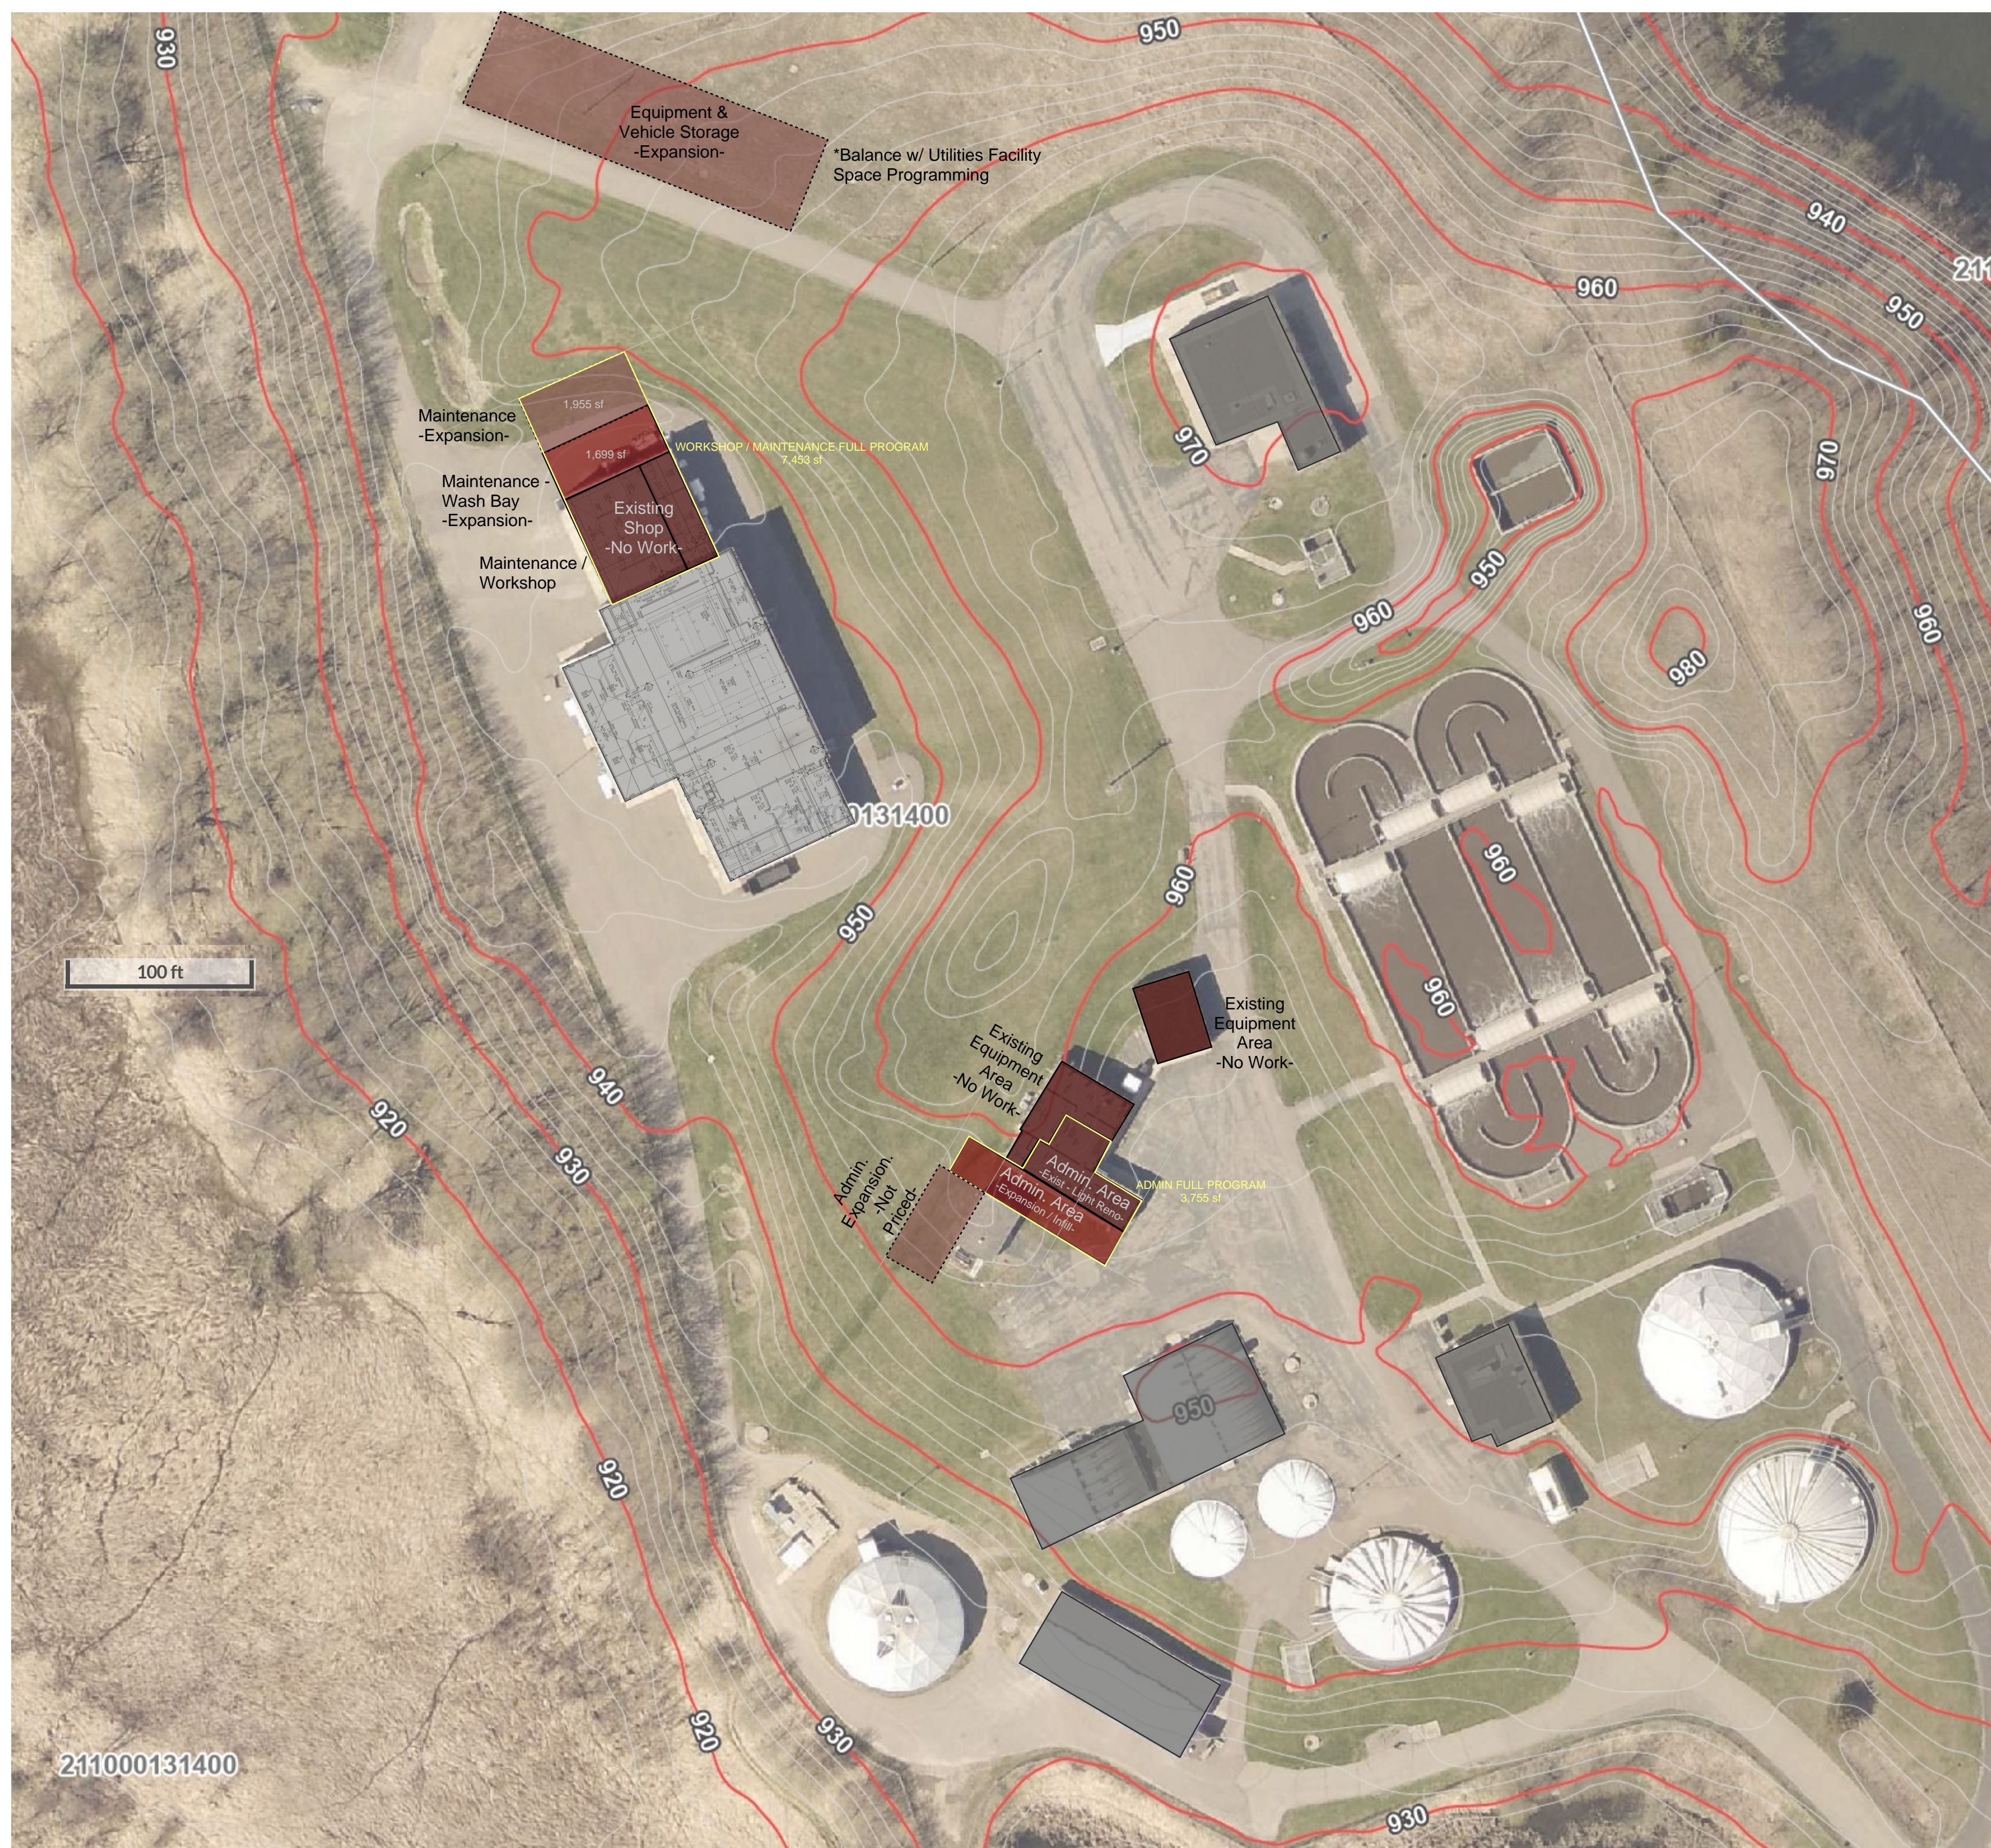
## SQUARE FOOTAGE ANALYSIS DIAGRAM

- EXISTING BUILDING
- CURRENT NEED AREA
- 20-YEAR PROJECTED NEED

City of Buffalo		Space Need Analysis Summary			
Functional Component	Existing SF	Wastewater			
		Existing Need	5-YR.	10-YR.	20-YR.
			Projection	Projection	Projection
		Area Required			
Administrative Area	1,915	3,515	3,702	3,702	3,702
Conditioned Storage	1,200	6,688	9,378	9,378	9,766
Equipment / Fleet Maintenance	3,505	3,328	3,328	3,328	3,328
Divisional Work Space	1,040	2,288	2,394	2,394	2,400
Net SF Subtotal	7,660	15,819	18,801	18,801	19,200
Circulation and Structure Allowance	NA	4,567	4,727	4,727	4,739
Programmed Gross SF	NA	20,387	23,529	23,529	23,940
Unconditioned Storage	NA				
Site Work Area(s)	NA
